Field Notes Nov. 15, 2000
Chenier Plain Sediment Burial Pipe Measurements

Chris Moeller, Mat Gunshor, Oscar Huh
Dale Winch, airboat pilot
University of Wisconsin – Madison
Louisiana State University

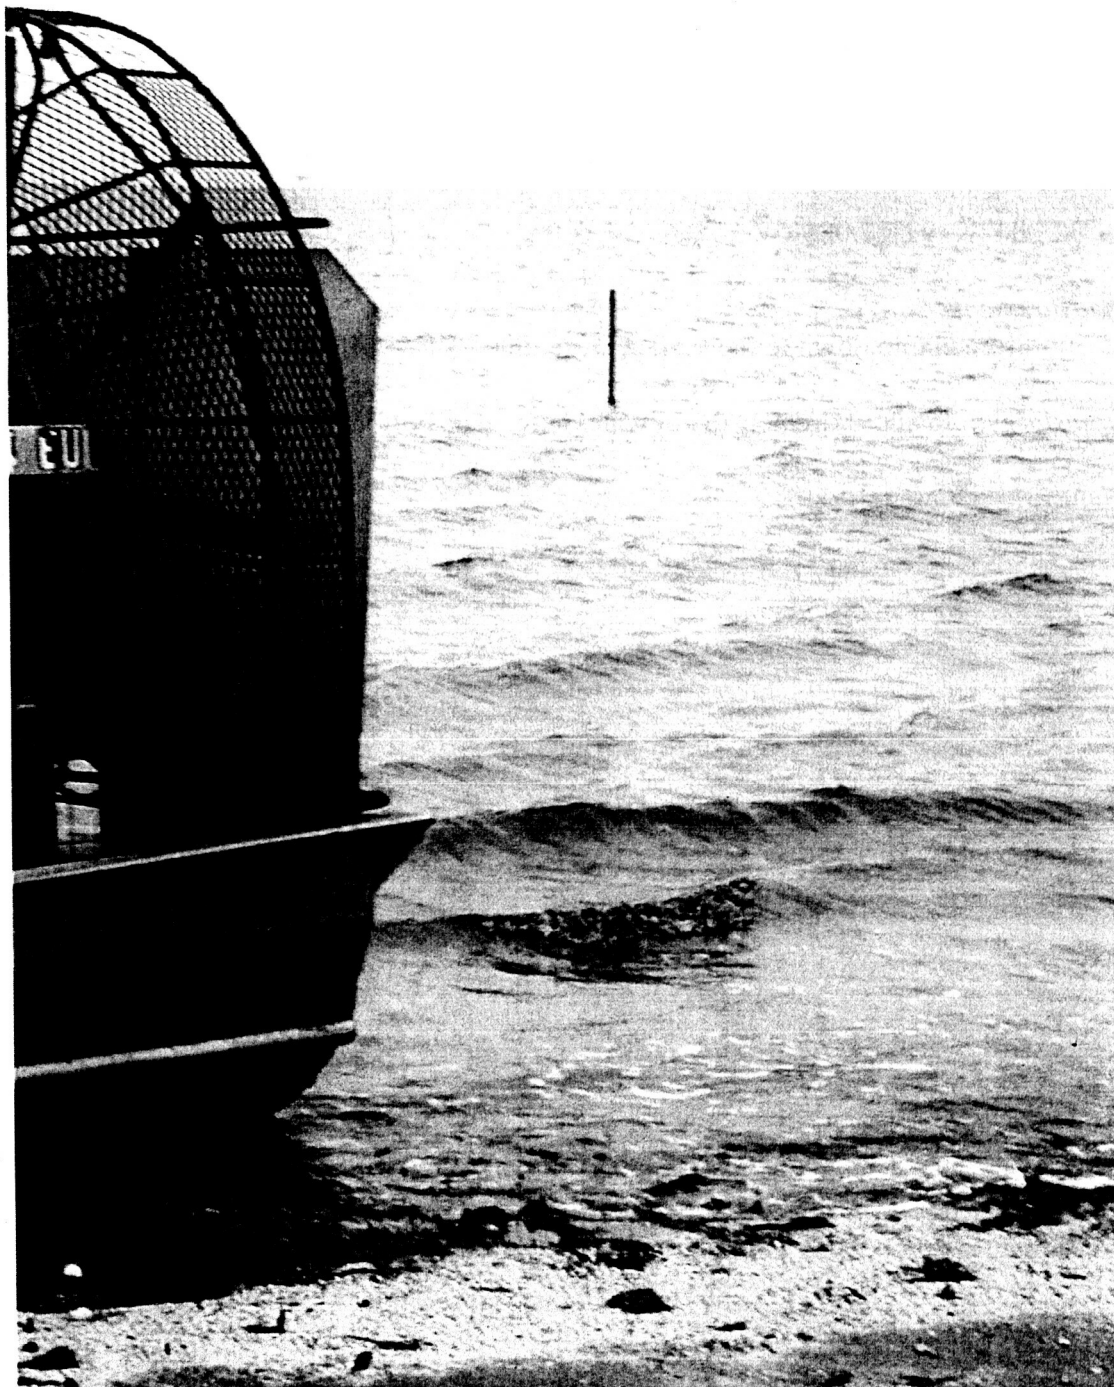
26. Facing pipe from shell beach at Eastern Erosion Site. In 1994, two pipes were installed at this site, reportedly one at shell beach ridge and a 2nd some 25 meters seaward. At this time, there is no evidence of a 2nd pipe at this site. Based on description given in the Nov. 1994 report, it is likely that erosion toppled the shell beach ridge pipe (only sunk about 1 meter into ridge) and that the remaining pipe is the seaward pipe, now some 50 meters from the shell beach ridge. (Dscn0162.jpg)

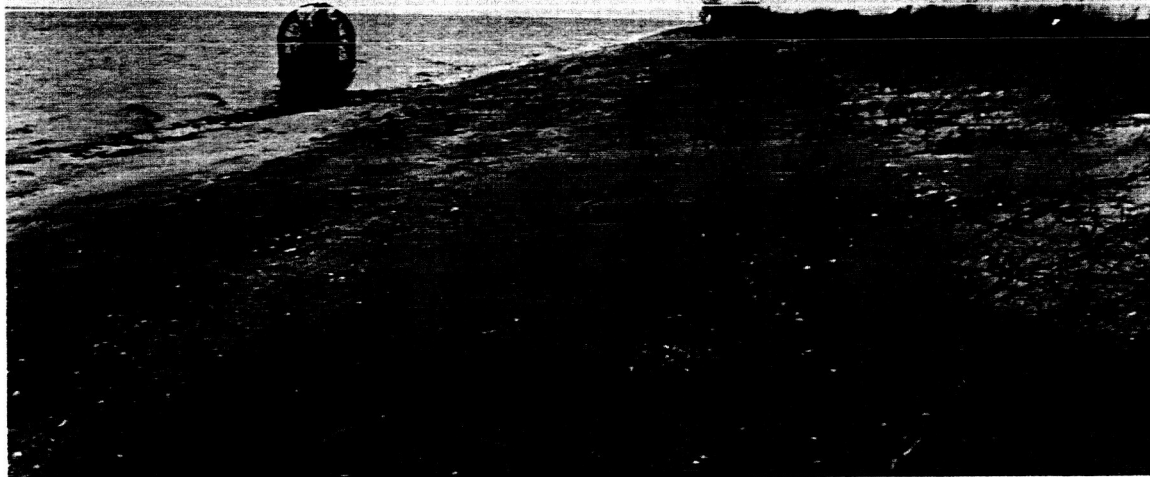
27. Facing west along beach at EES. No evidence of mud deposits on beach.
(Dscn0163.jpg)

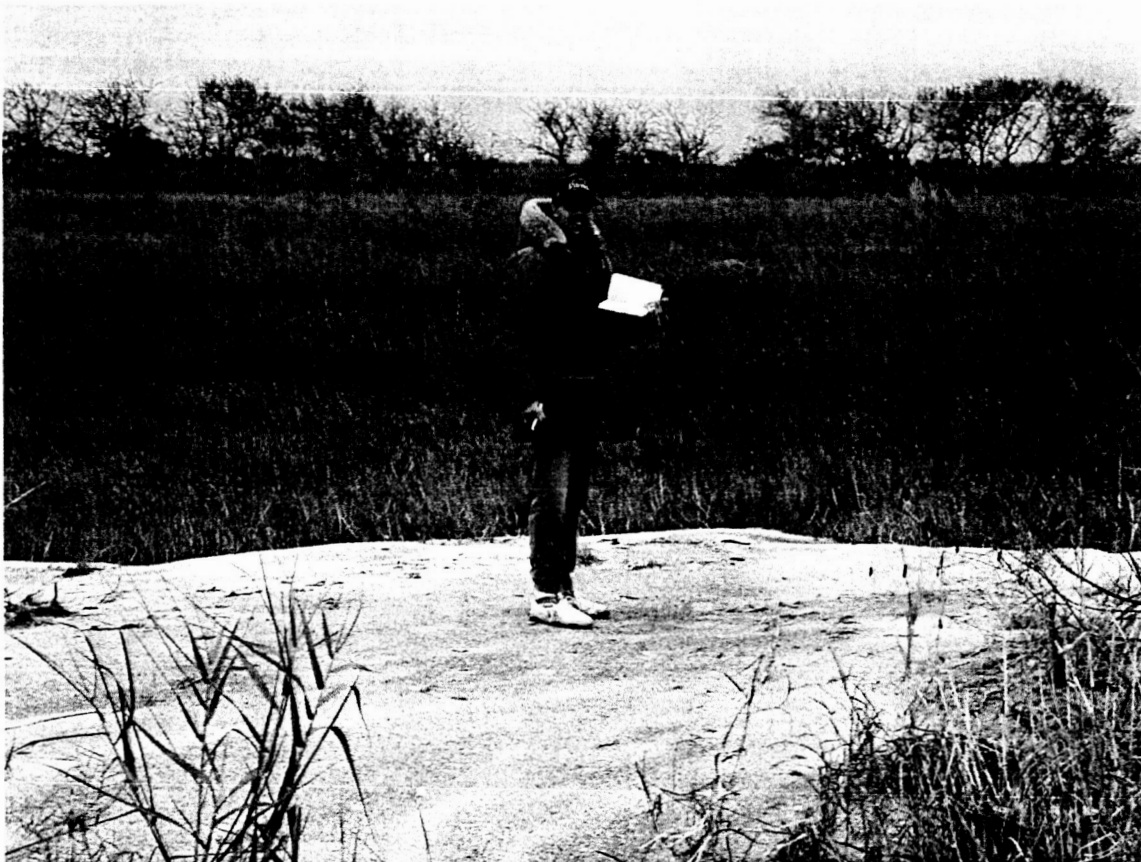
28. Facing inland some 15 meters inland of shell beach ridge at EES. Mat is standing on a shell beach overwash lobe. The grassy lowland region beyond contained some standing water. In the background is a chenier populated by Oak trees.
(Dscn0164.jpg)

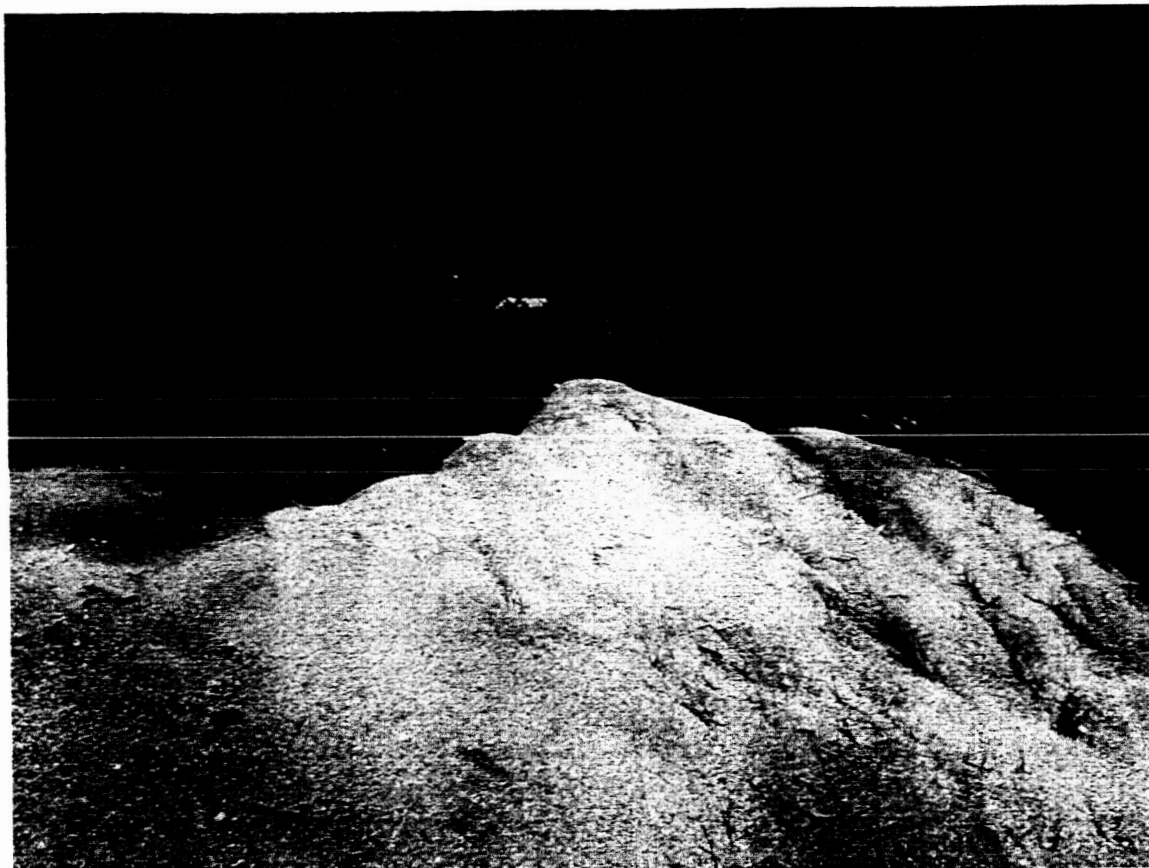
29. Shell beach overwash lobes, taken from Mat's position in picture 28, facing North.
(Dscn0165.jpg)

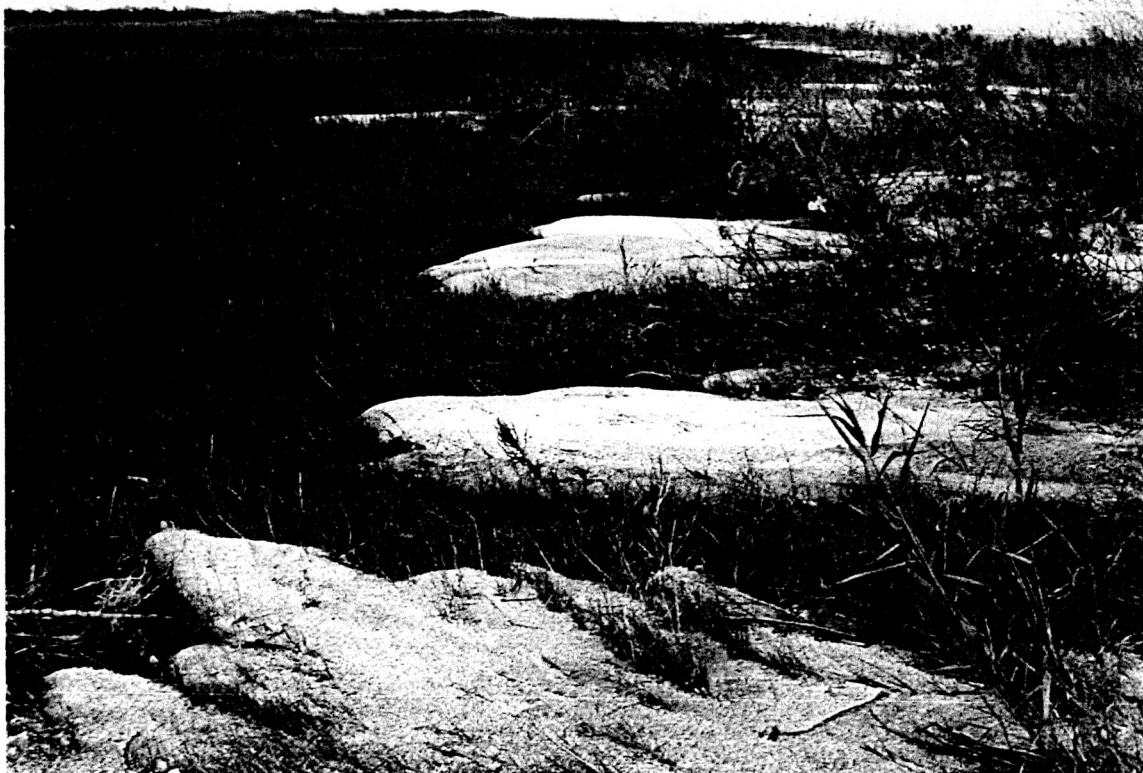
30. A series of shell beach overwash lobes, taken from Mat's position in picture 28 facing East. (Dscn0166.jpg)
